## (COA) Conditionned Oriented Assessment

Technical assessment of a complete turbine excluding tower outside and rotor blades

WTG-Type: REpower MD77-1.5MW

Wind farm and no. In farm: Menil La Horgne, E5-R70620

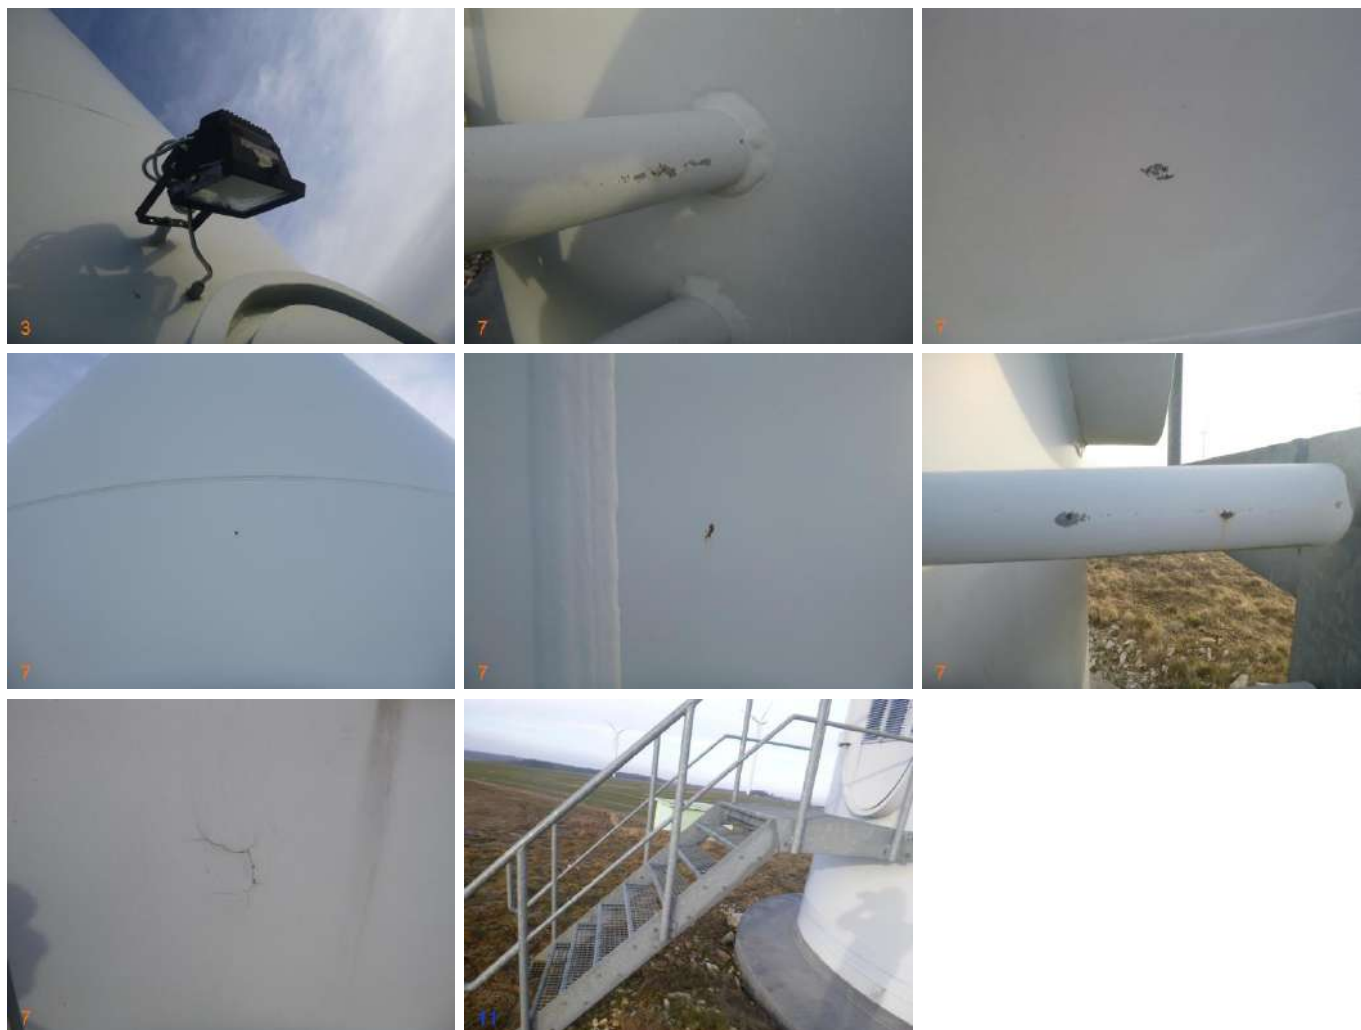
| 3 | P | 📷 Foundations and tower, Tower outside : Outside tower lamp. Defective. To repair. |
| 7 | P | 📷 Foundations and tower, Tower outside : 1st tower section. Paint damage. Corrosion present. Should be repaired. |
| 11 | E | 📷 Foundations and tower, Tower outside : Tower access stairs. A welding point should be performed at the global bolts for prevention of theft. |

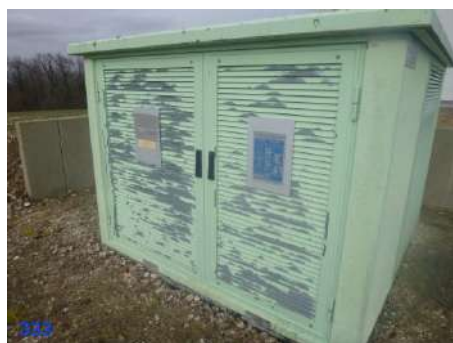
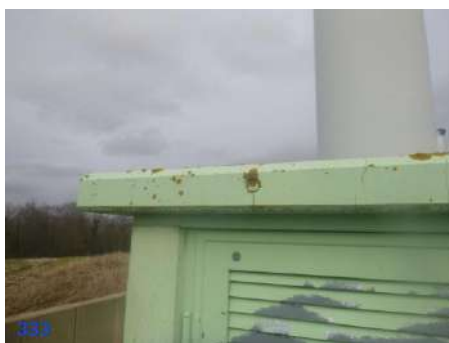
Grid connections : HV room. Cracks and mildew are observed. A cleaned and a new coating protection is required.

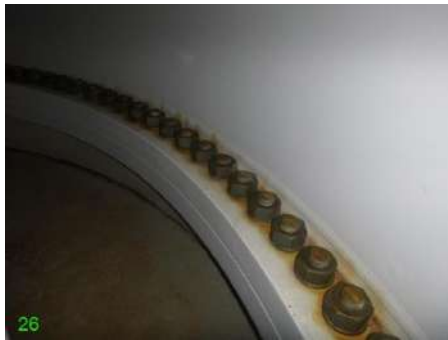
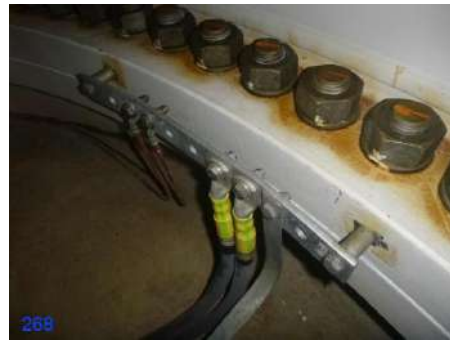
- 21    V    Grid connections, Transformer : Visual state. Good condition.
- 26    V    📷 Foundations and tower, Bolts and flanges : Flange basement section-1st tower section. Bolts protected by wax.
- 268    E    📷 Foundations and tower, Cables / Electrical installations : Earthing wires. The main beam connections should be protected with wax.
- 305    P    Foundations and tower, Cables / Electrical installations : Cable duct. Not sealed.

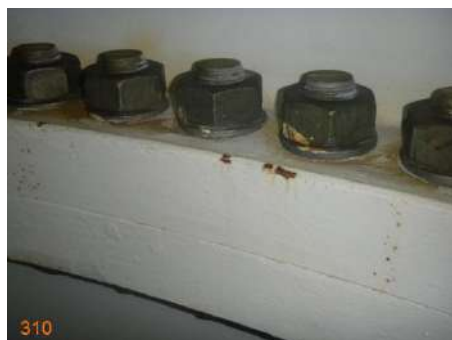
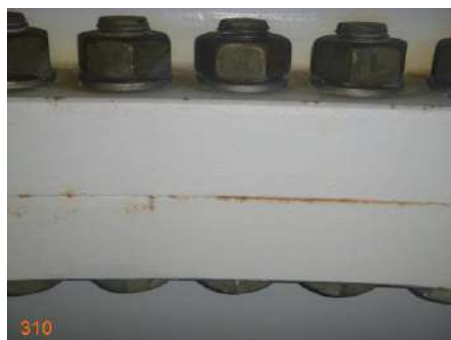
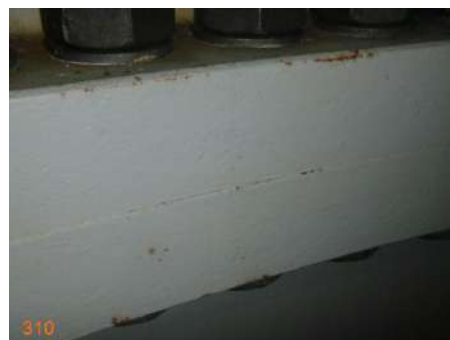
Foundations and tower, Bolts and flanges : Flange Coating scratch. A new coating protection should be applied.
- 311 P Identification and labels : Maximum load sticker. Missing.

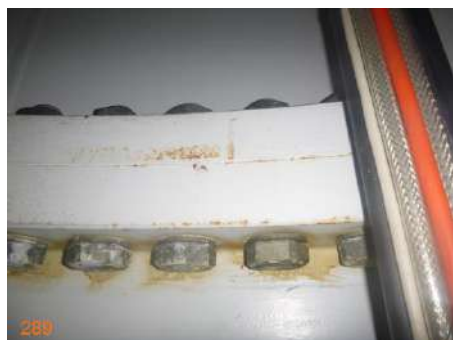
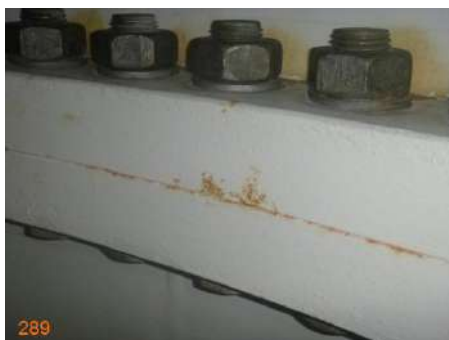
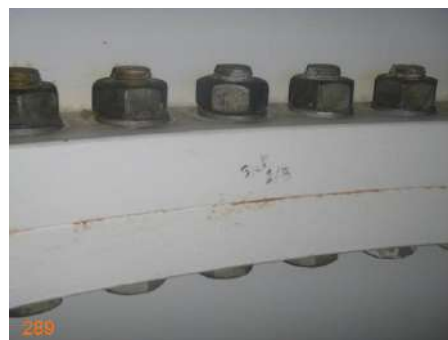
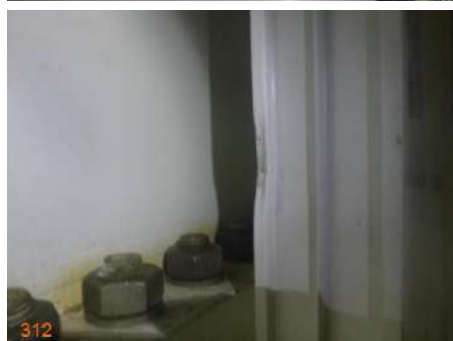
- 116 P Identification and labels : Max. load sticker. Missing.
- 117 P Identification and labels : Safety stickers. Missing.
- 289 P 📷 Foundations and tower, Bolts and flanges : Corrosion protection. Seriously damaged. To repair.
- 312 P 📷 Foundations and tower, Cables / Electrical installations : Stator bus bar One cover is damaged.

- Tower flanges damages must be repaired.
- Anchoring point for abseil device must be clarified.
- Additional protection must be installed at the cables loop's platform.
- Yaw gearing area must be cleaned from excess of grease.
- Hub enclosure must be cleaned from grease leakages.
- Oil leakage at the gear oil main block filter must be eliminated.
- Nacelle main carrier's paint flaking must be repaired.
- Periodic inspections on the gearbox should be done
- REpower hotline number stickers marking must be refreshed.
- The high speed shaft alignment must be re-worked.

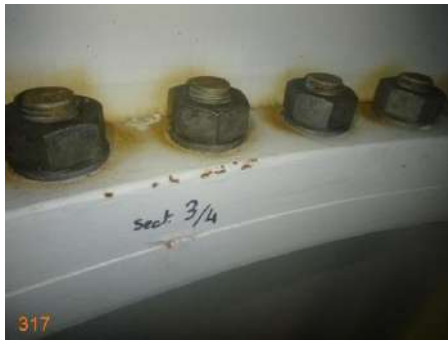
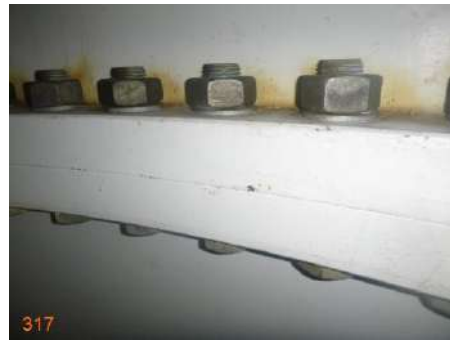
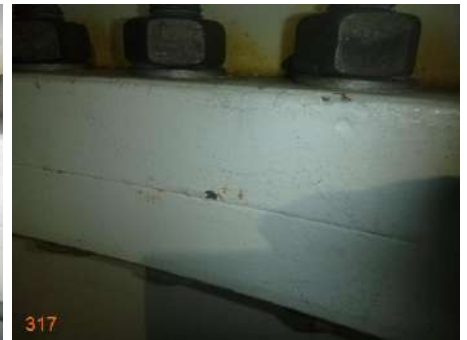
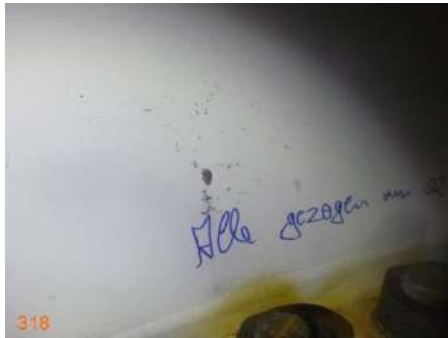
- 315 P Identification and labels : Safety stickers. Missing.
- 317 P 📷 Foundations and tower, Bolts and flanges : Corrosion protection. Seriously damaged. To repair.
- 318 P 📷 Foundations and tower, Tower inside : Tower wall Damaged. The concerned area must be repaired.
- 319 P Identification and labels : Max load sticker. Missing.

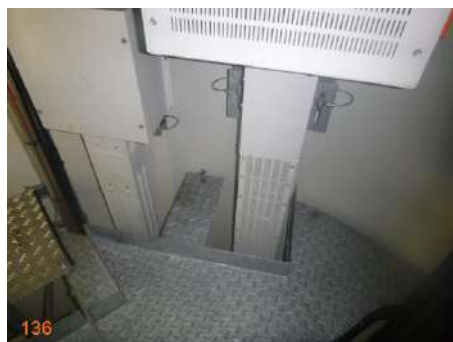
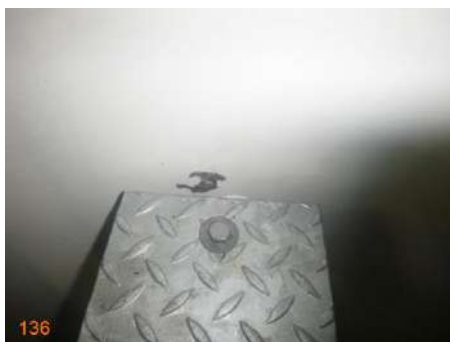
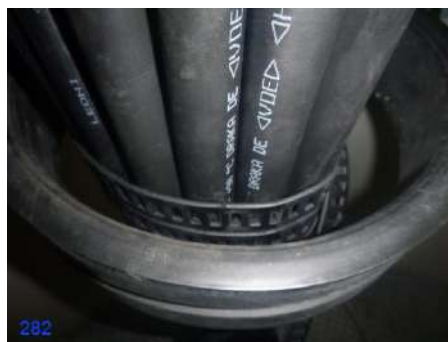
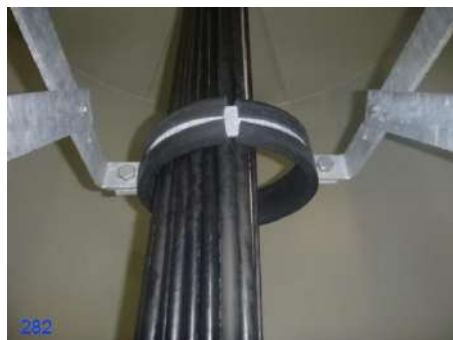
- 132 P Identification and labels : Max. load sticker. Missing.
- 134 P Health, safety and ascent systems : Loop platform. Important gap between the platform and the loop cable. Do not follow the recommendations of the EN 50308. Must be retrofited.
- 136 P 📷 Foundations and tower, Tower inside : Tower wall corrosion protection. Damaged. To repair.
- 282 I 📷 Foundations and tower, Cables / Electrical installations : Cables loop conditions. Acceptable and harmless abrasion.

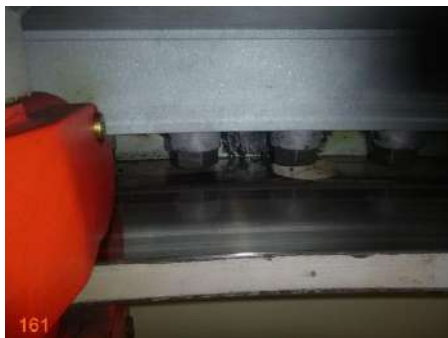
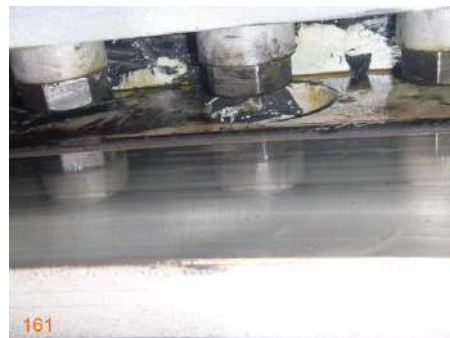
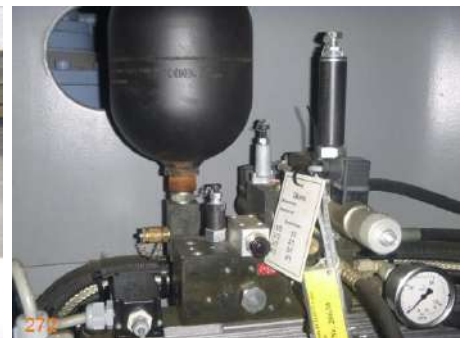
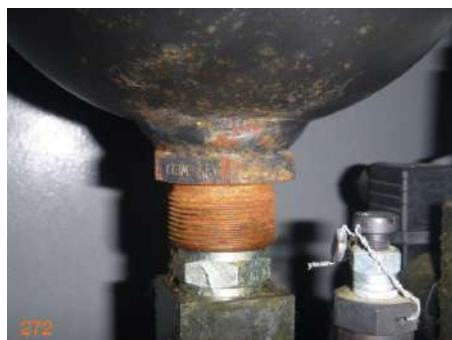
Nacelle, Yaw plate / Yaw system : Yaw brake disk. Grease contamination. The nacelle bearing sealing get tired. To exchange.
- 164 P Identification and labels : Safety stickers. Missing.
- 165 P Identification and labels : Max. load sticker. Missing.
- 166 E Foundations and tower, Platforms inside installation : Acces ladder. Should be equipped with anti slip pads.
- 272 P

Nacelle, Hydraulics : Hydraulic station. Corrosion at the accumulator.
- 273 V Foundations and tower, Platforms inside installation : Additional stool. Present.

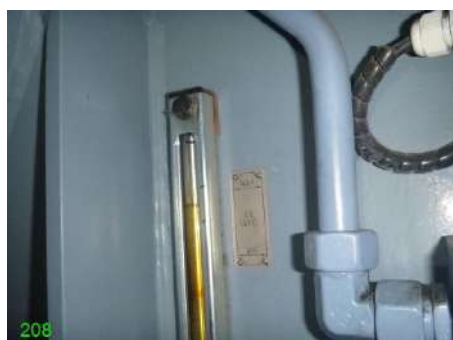
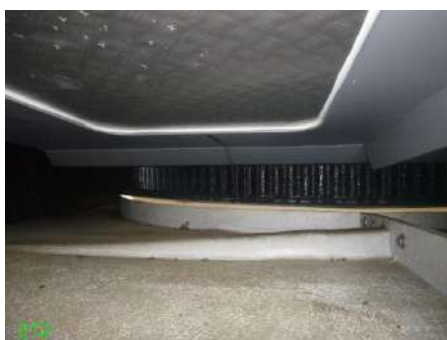
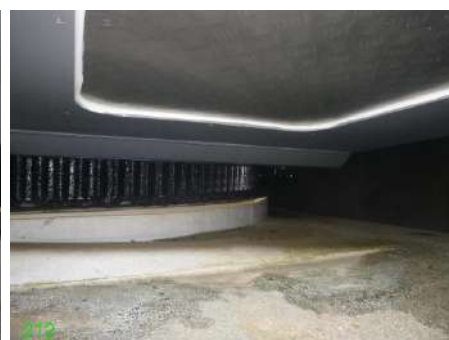
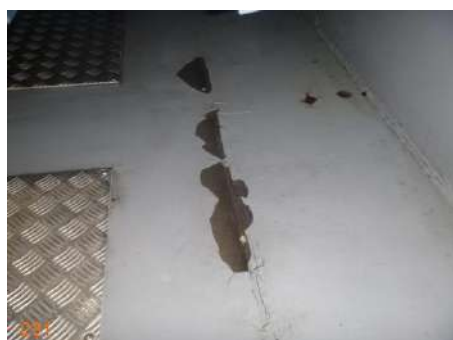
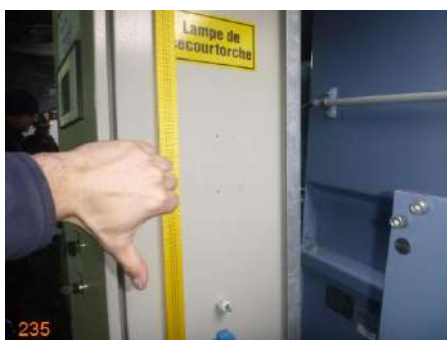
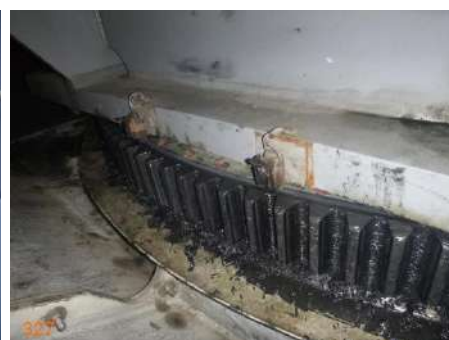
- 187 V Health, safety and ascent systems : First aid kit. Present.
- 191 P Drivetrain, Generator : Generator slipring. Carbon Brushes. Irregular wear.
- 193 V Nacelle, Platforms inside installation : Cleanliness. Good condition.

- 198 V Drivetrain, High speed shaft brake : Brake disk. Good geometry.
- 200 P Identification and labels : REpower Hotline number. Erased.
- 276 P Nacelle, Nacelle housing : Yaw gearing area. Seriously contaminated with excess of grease. To clean.

- 293 P Drivetrain, Gearbox / lubricating system : Gear oil main block filter. Leakage. To eliminate.
- 321 P Nacelle, Electrical cabinets : Top controller cabinet. Important cracks at the rear cabinet's wall. Retrofit must be performed.

- 208 V Drivetrain, Gearbox : Oil level. Ok.
- 212 V <sup>Ⓜ</sup> Nacelle, Nacelle housing : Lower nacelle casing. Clean
- 217 P Health, safety and ascent systems : On board hoist. Rail. No restriction displayed for the use as an attachment point for the PPE against fall. Ask to REpower the proof that the rail can be used as an attachment point for the PPE against fall.

- 224 V Drivetrain, Gearbox / lubricating system : Cooler. Good conditions.
- 229 V Nacelle, Yaw plate / Yaw system : Yaw gear. Oil level. Ok.
- 231 P <sup>Ⓜ</sup> Nacelle, Chassis / Structure : Coating protection. Important paint flaking. To repair.

- 235 P <sup>Ⓜ</sup> Nacelle, Cables / Electrical installations : Nacelle hand lamp. Missing.
- 301 I Drivetrain, Gearbox : Vidéo endoscopy. See additionnal report. réf: Ménil la Horgne\_E5\_R70620\_VE report

- 326 V Nacelle, Yaw plate / Yaw system : Yaw gearing. Properly greased.
- 327 P <sup>Ⓜ</sup> Lightning protection equipment : Nacelle/tower continuity. The brushes are contaminated with excess of grease. The supports are contaminated with corrosion. To correct.

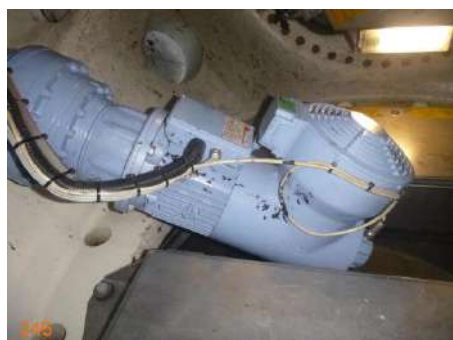
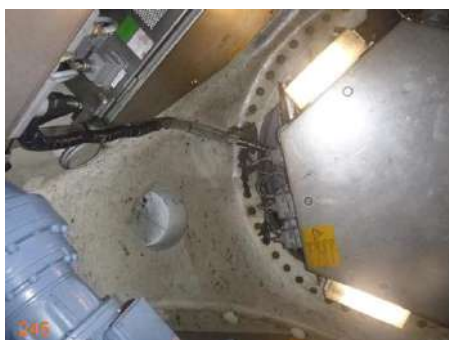
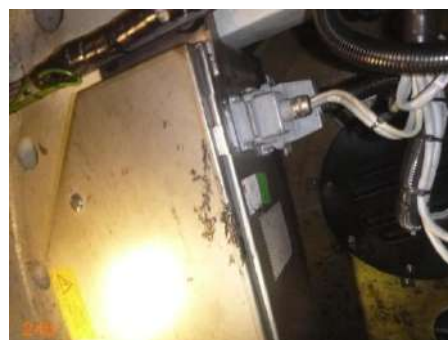
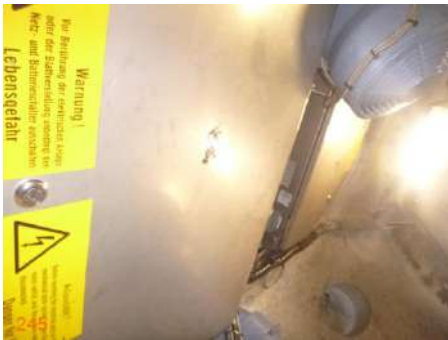
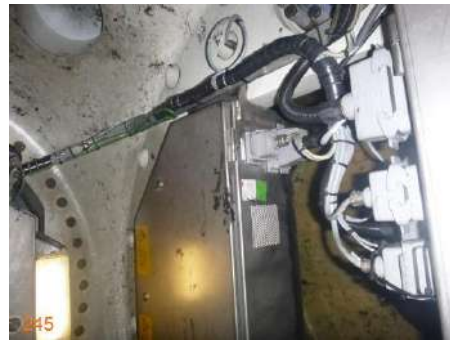
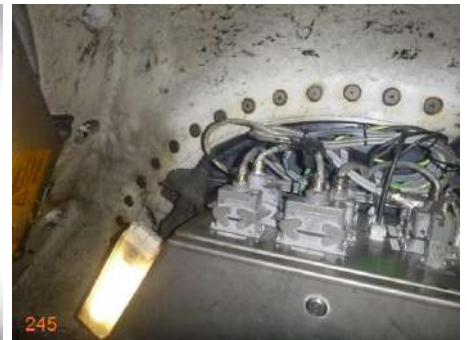
Hub system : Hub enclosure. Contaminated with excess of grease. To clean.
- 246 P Identification and labels : Blade root platform. Maximum admissible load. Missing.
- 259 P Identification and labels : Warning and informations stickers. Must be translated in french.
