## (COA) Conditionned Oriented Assessment

Technical assessment of a complete turbine excluding tower outside and rotor blades

WTG-Type: REpower MD77-1.5MW

Wind farm and no. In farm: Menil La Horgne, E5-R70620

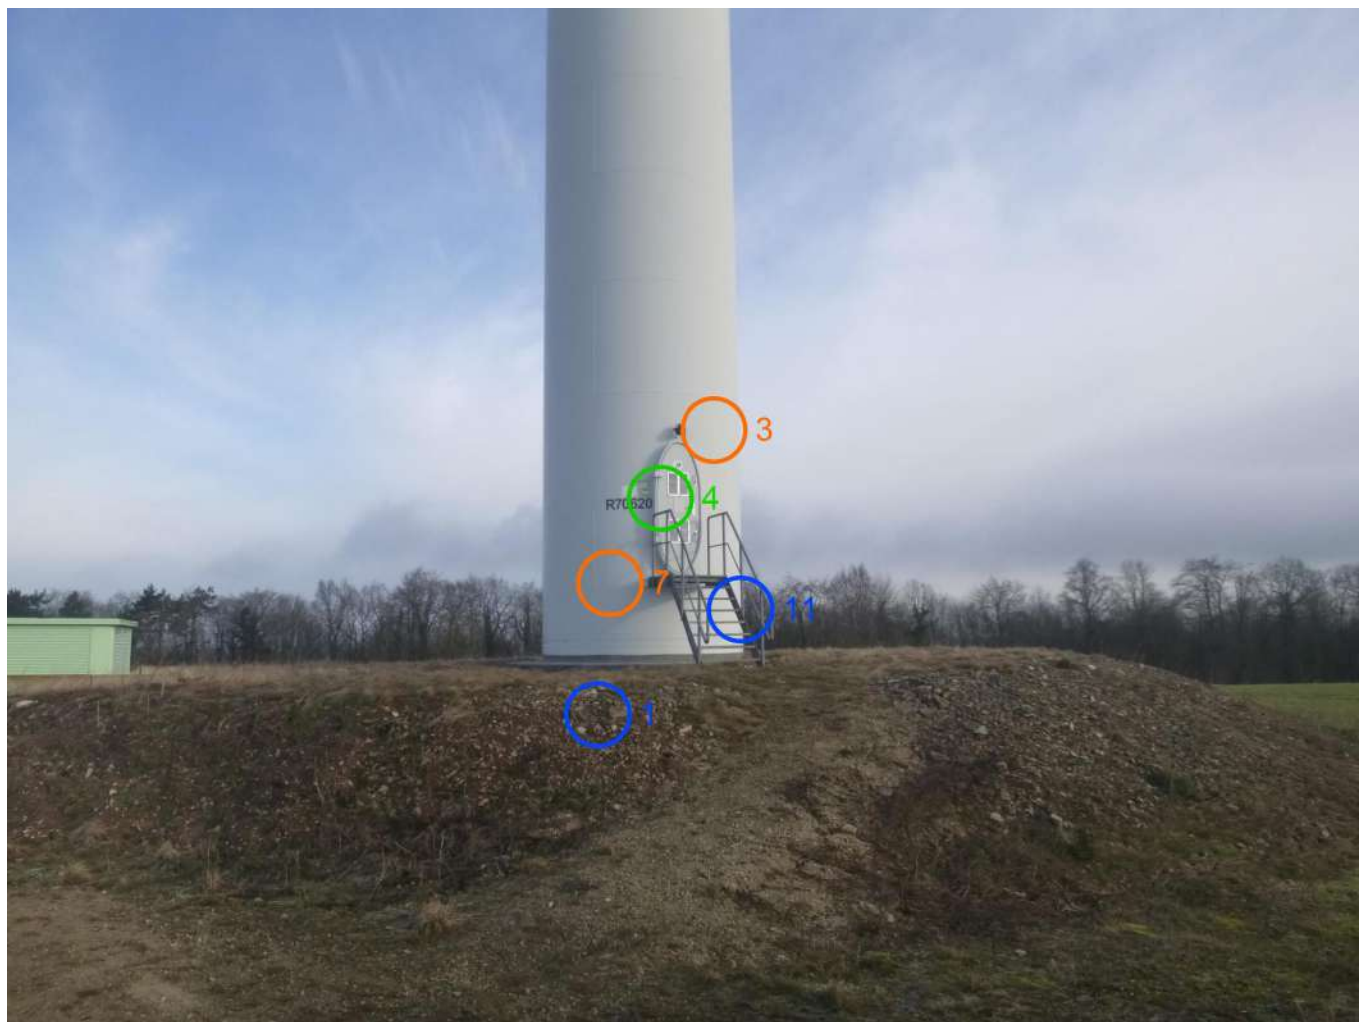
### D.1 Surrounding

| 1 | I | Identification and labels : ICPE warning sign close to the wind turbine. Stick on the tower. Should be put in a better place not to close to the turbine. |
| 3 | P | 📷 Foundations and tower, Tower outside : Outside tower lamp. Defective. To repair. |
| 7 | P | 📷 Foundations and tower, Tower outside : 1st tower section. Paint damage. Corrosion present. Should be repaired. |
| 11 | E | 📷 Foundations and tower, Tower outside : Tower access stairs. A welding point should be performed at the global bolts for prevention of theft. |

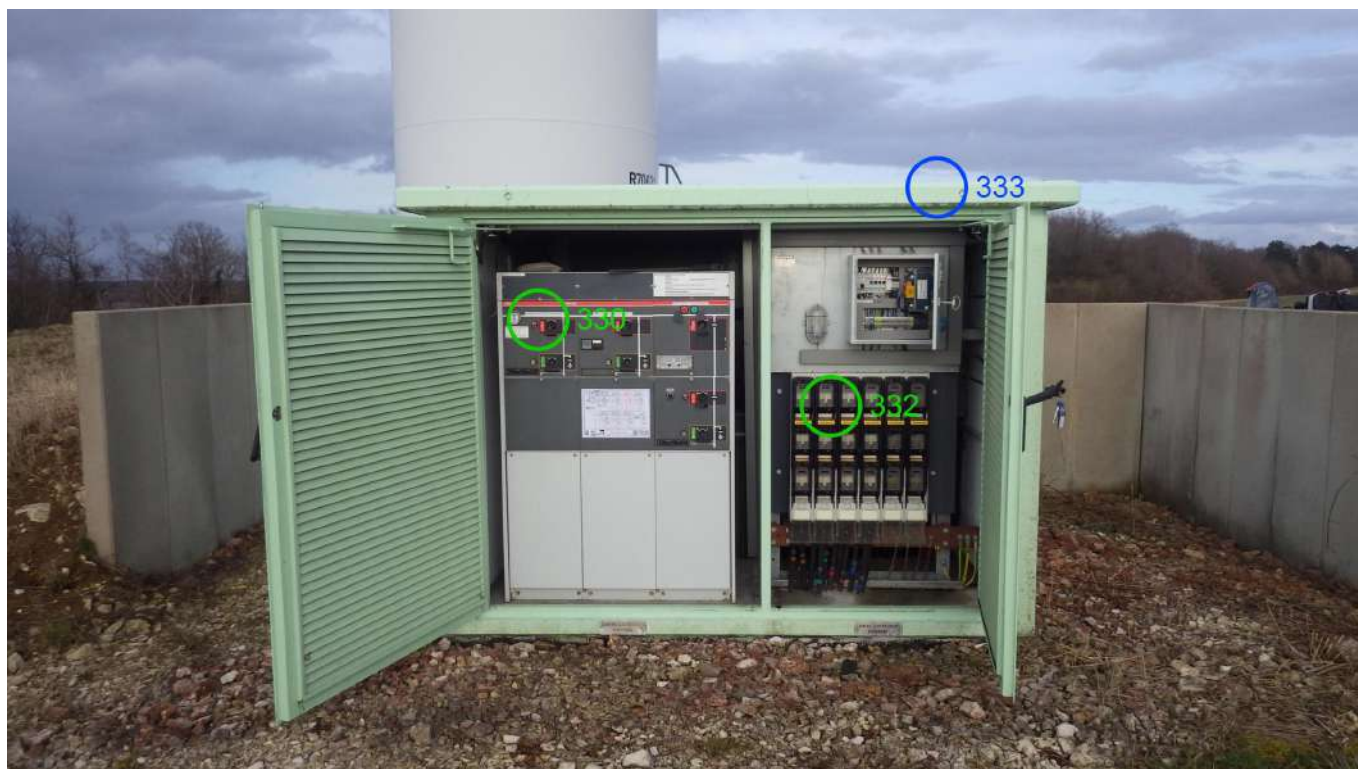
## D.2 HV station

- 330 V Grid connections, High Voltage switchgear : SF6 gaz. Correct pressure.
- 332 V Grid connections : Power cabinets fuses. Properly greased.
- 333 E

Grid connections : HV room. Cracks and mildew are observed. A cleaned and a new coating protection is required.

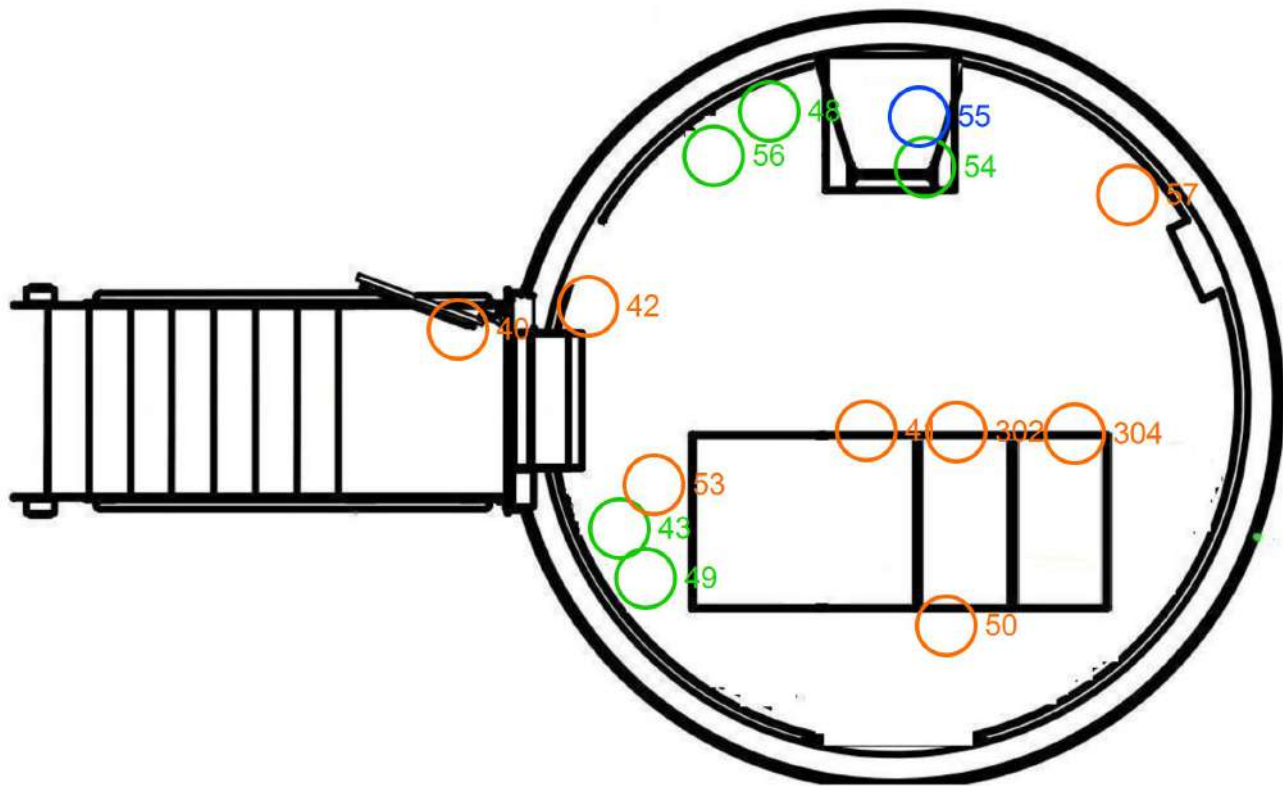
## D.3 Entrance platform

- 40 P Foundations and tower, Entrance : Entrance door. Antipanic opening system. Missing.
- 41 P

- 42 P Identification and labels : CE Nameplate. Do not follow the recommendations of IEC 61400-1 and European Machine Directive .
- 43 V Health, safety and ascent systems : First aid kit. Present.

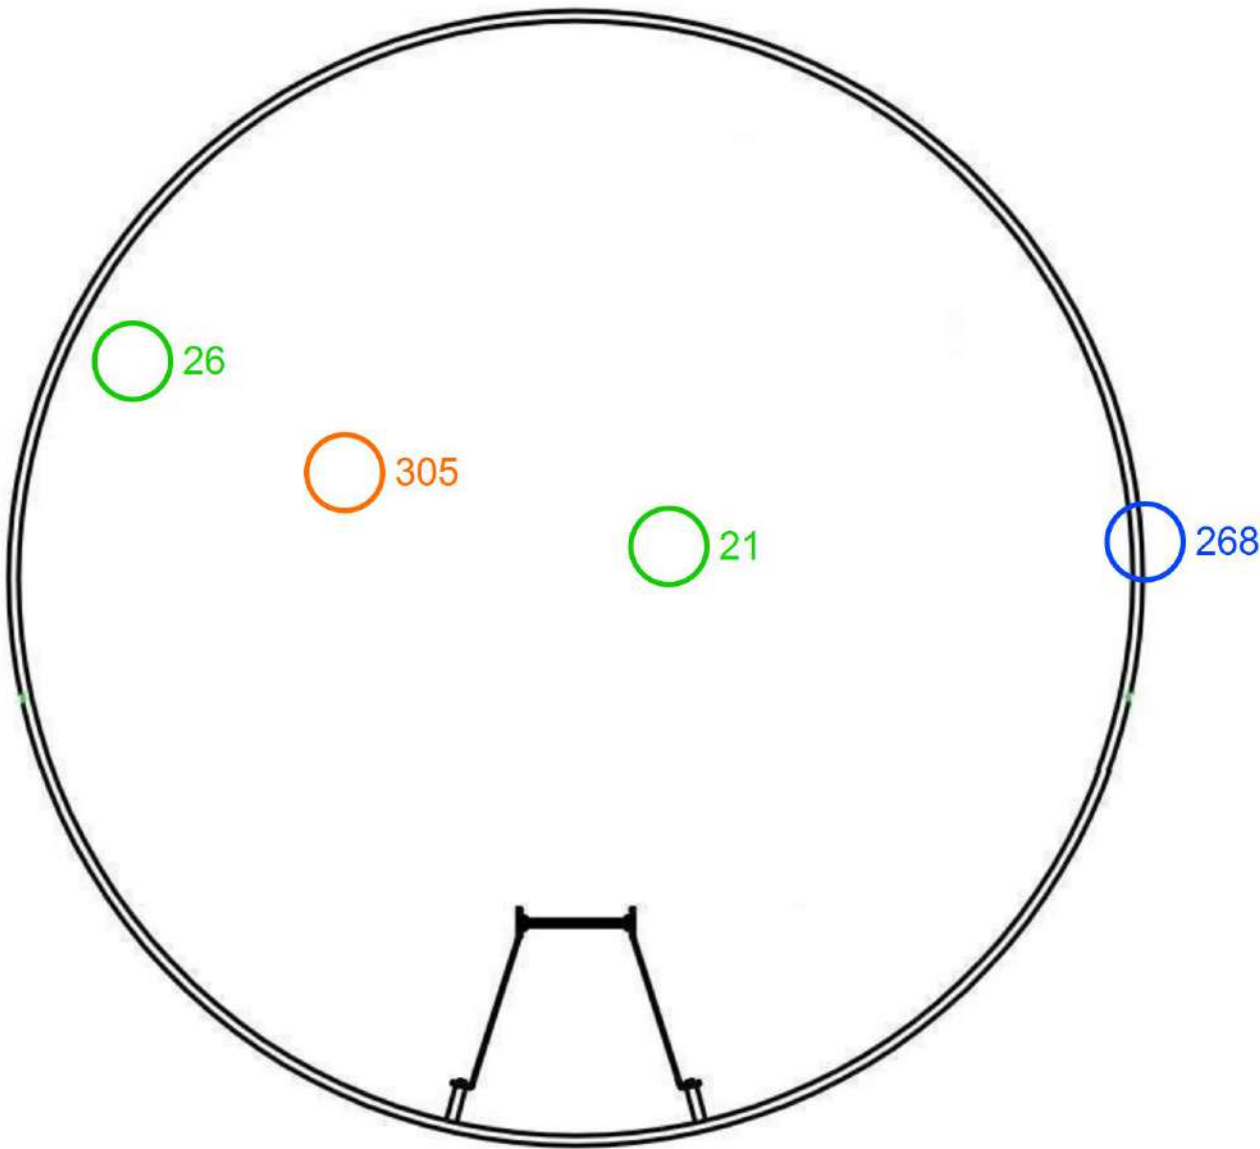
D.4 Cellar

- 21    V    Grid connections, Transformer : Visual state. Good condition.
- 26    V    📷 Foundations and tower, Bolts and flanges : Flange basement section-1st tower section. Bolts protected by wax.
- 268    E    📷 Foundations and tower, Cables / Electrical installations : Earthing wires. The main beam connections should be protected with wax.
- 305    P    Foundations and tower, Cables / Electrical installations : Cable duct. Not sealed.

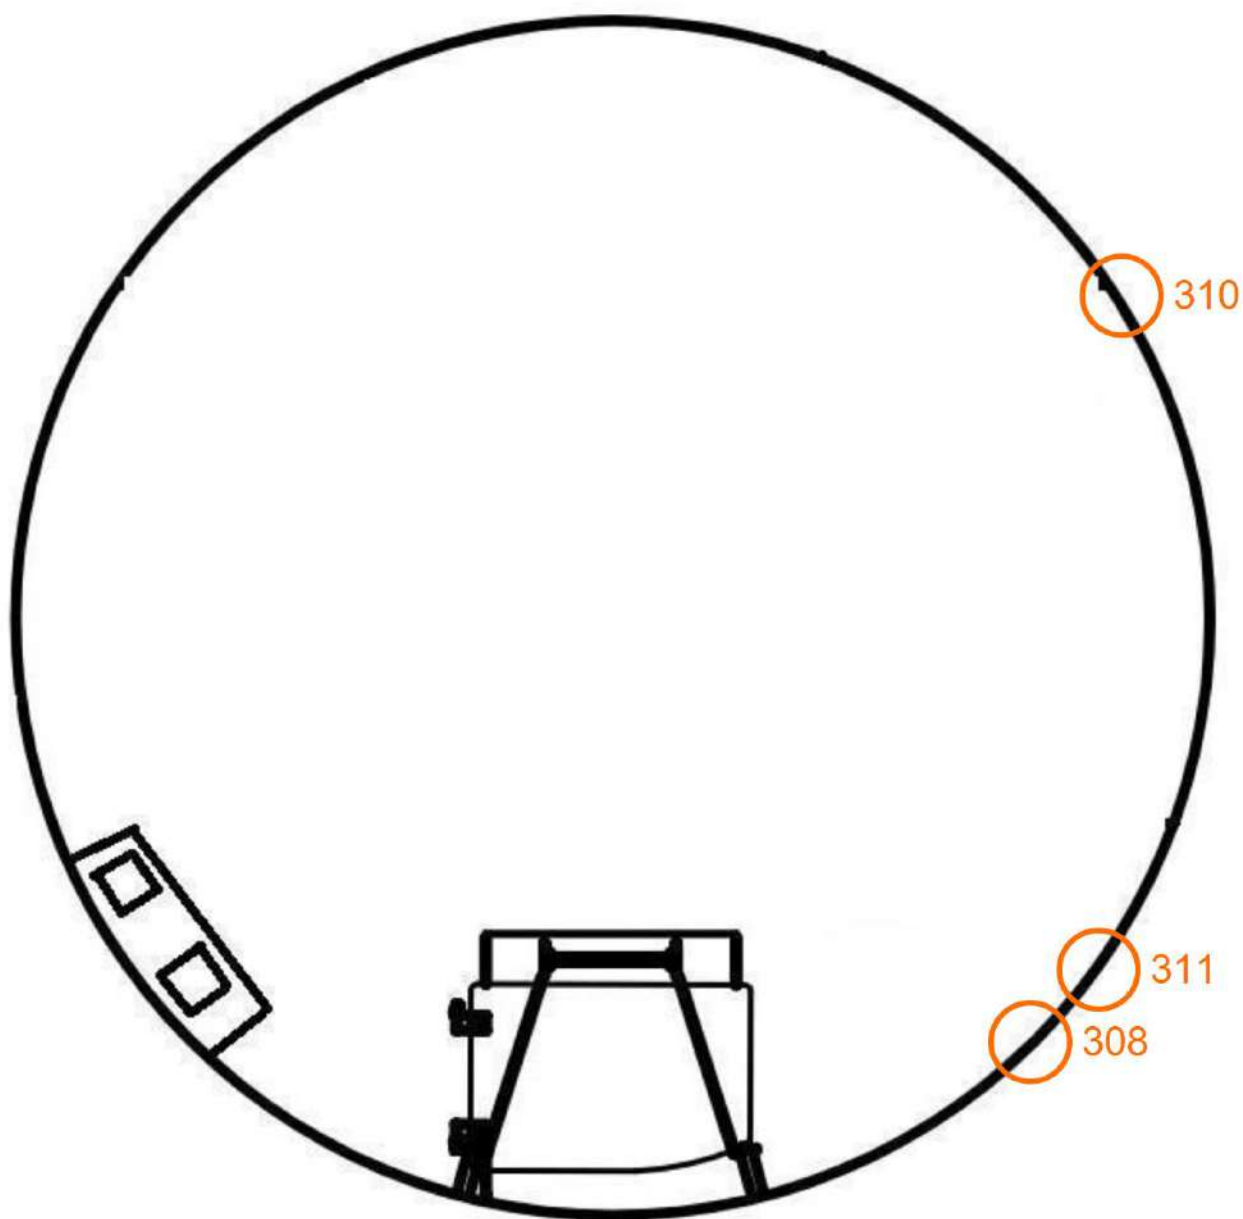
## D.5 Tower platform sections 1-2

- 308 P Identification and labels : Safety stickers. Missing.
- 310 P

Foundations and tower, Bolts and flanges : Flange Coating scratch. A new coating protection should be applied.
- 311 P Identification and labels : Maximum load sticker. Missing.

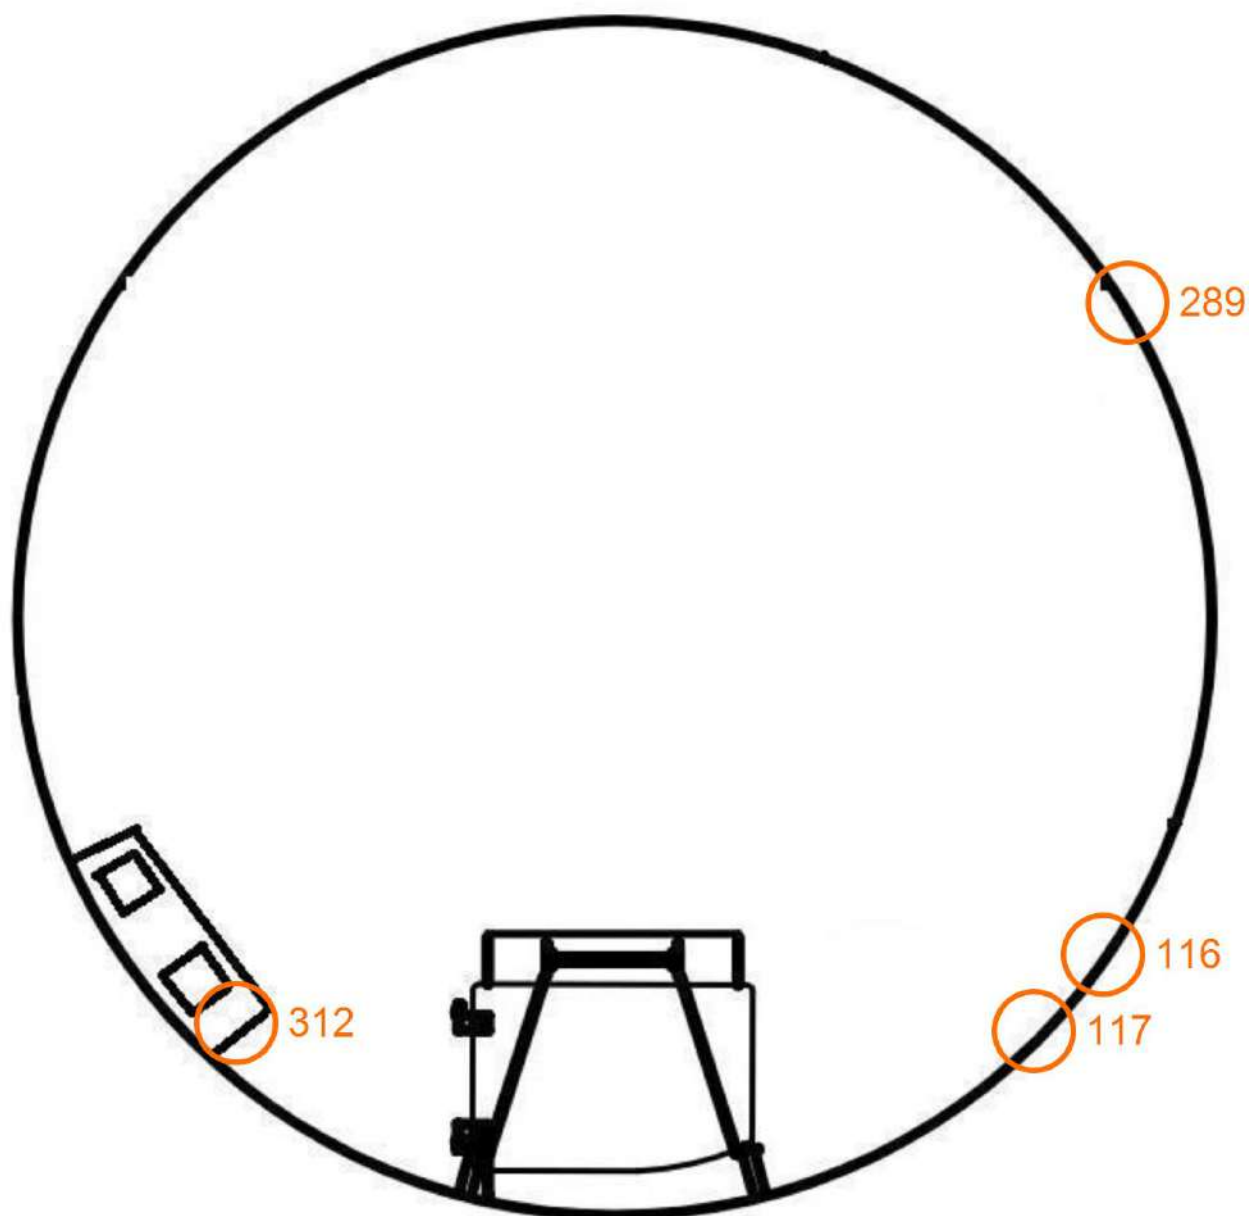
## D.6 Tower platform sections 2-3

- 116 P Identification and labels : Max. load sticker. Missing.
- 117 P Identification and labels : Safety stickers. Missing.
- 289 P 📷 Foundations and tower, Bolts and flanges : Corrosion protection. Seriously damaged. To repair.
- 312 P 📷 Foundations and tower, Cables / Electrical installations : Stator bus bar One cover is damaged.

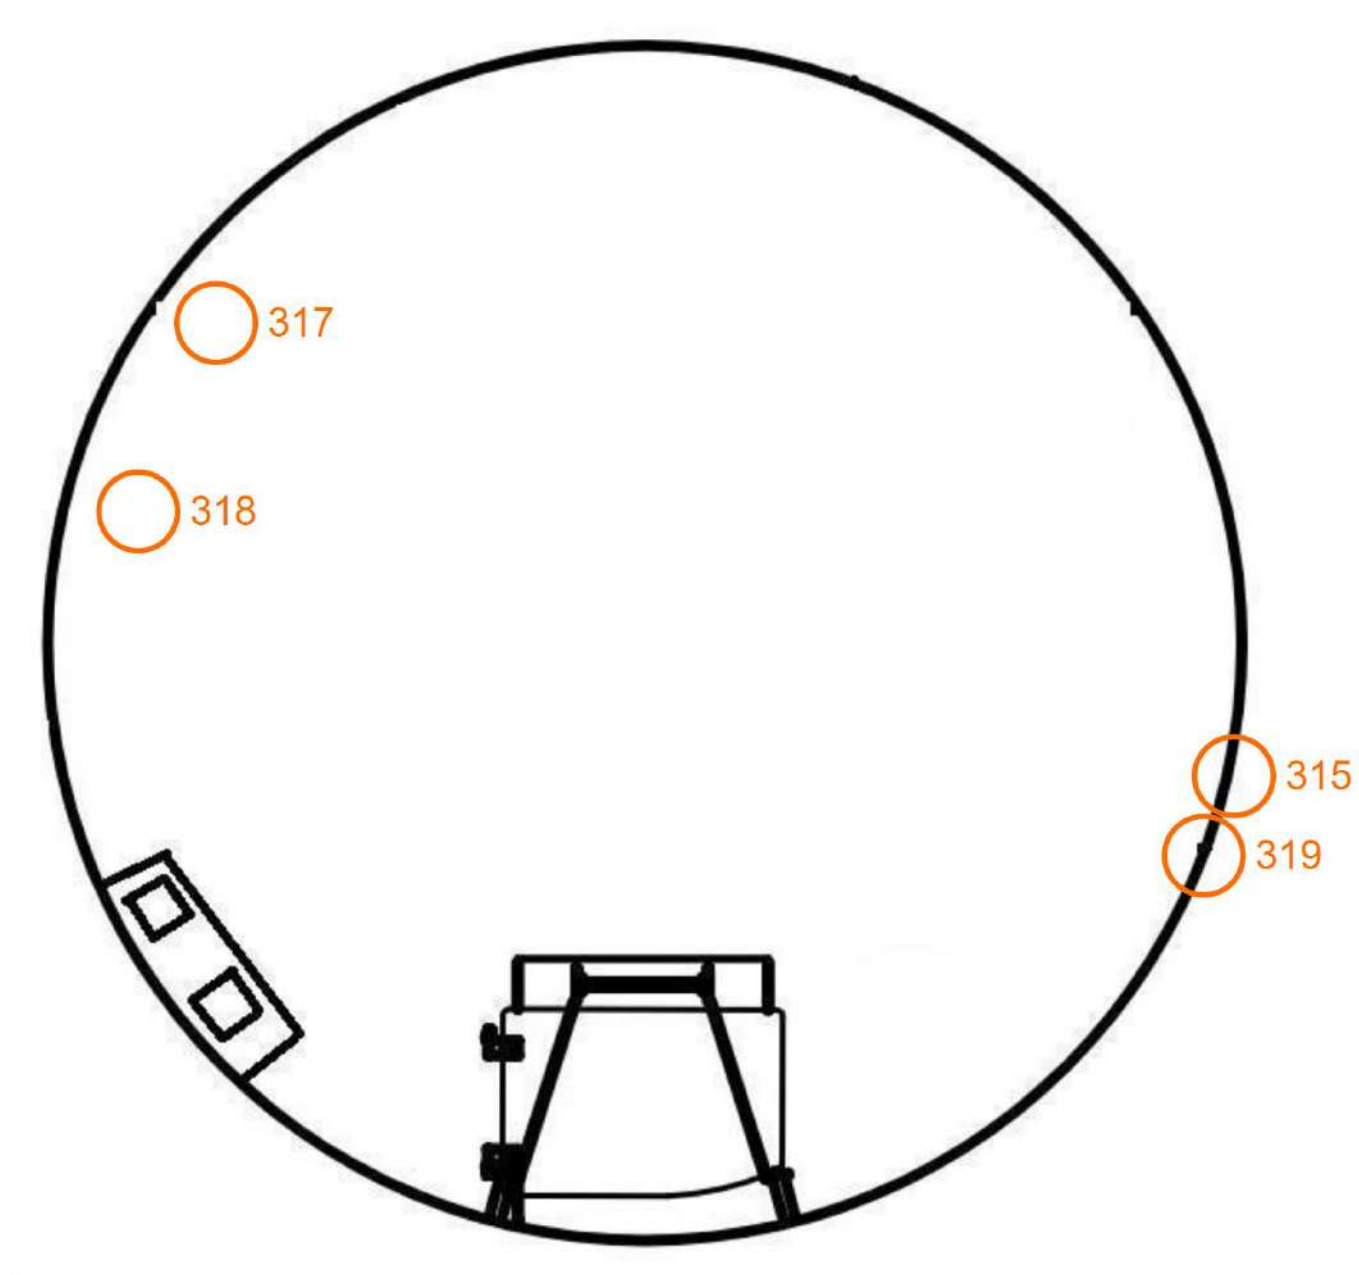
## D.7 Tower platform sections 3-4

- 315 P Identification and labels : Safety stickers. Missing.
- 317 P 📷 Foundations and tower, Bolts and flanges : Corrosion protection. Seriously damaged. To repair.
- 318 P 📷 Foundations and tower, Tower inside : Tower wall Damaged. The concerned area must be repaired.
- 319 P Identification and labels : Max load sticker. Missing.

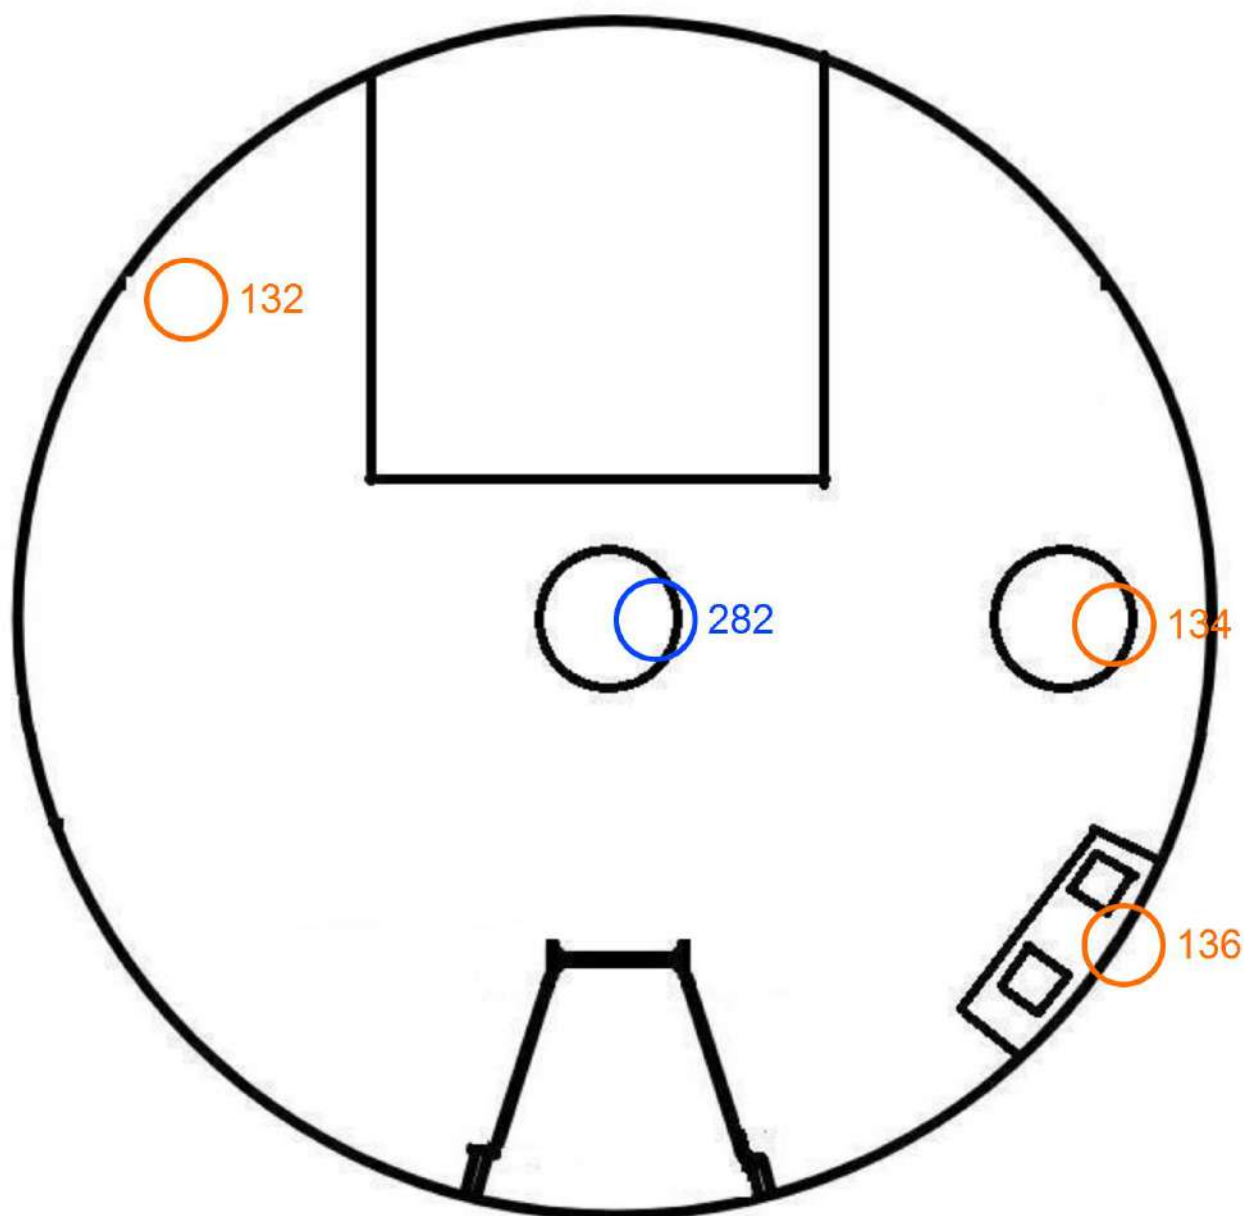
## D.8 Loop platform

- 132 P Identification and labels : Max. load sticker. Missing.
- 134 P Health, safety and ascent systems : Loop platform. Important gap between the platform and the loop cable. Do not follow the recommendations of the EN 50308. Must be retrofited.
- 136 P 📷 Foundations and tower, Tower inside : Tower wall corrosion protection. Damaged. To repair.
- 282 I 📷 Foundations and tower, Cables / Electrical installations : Cables loop conditions. Acceptable and harmless abrasion.

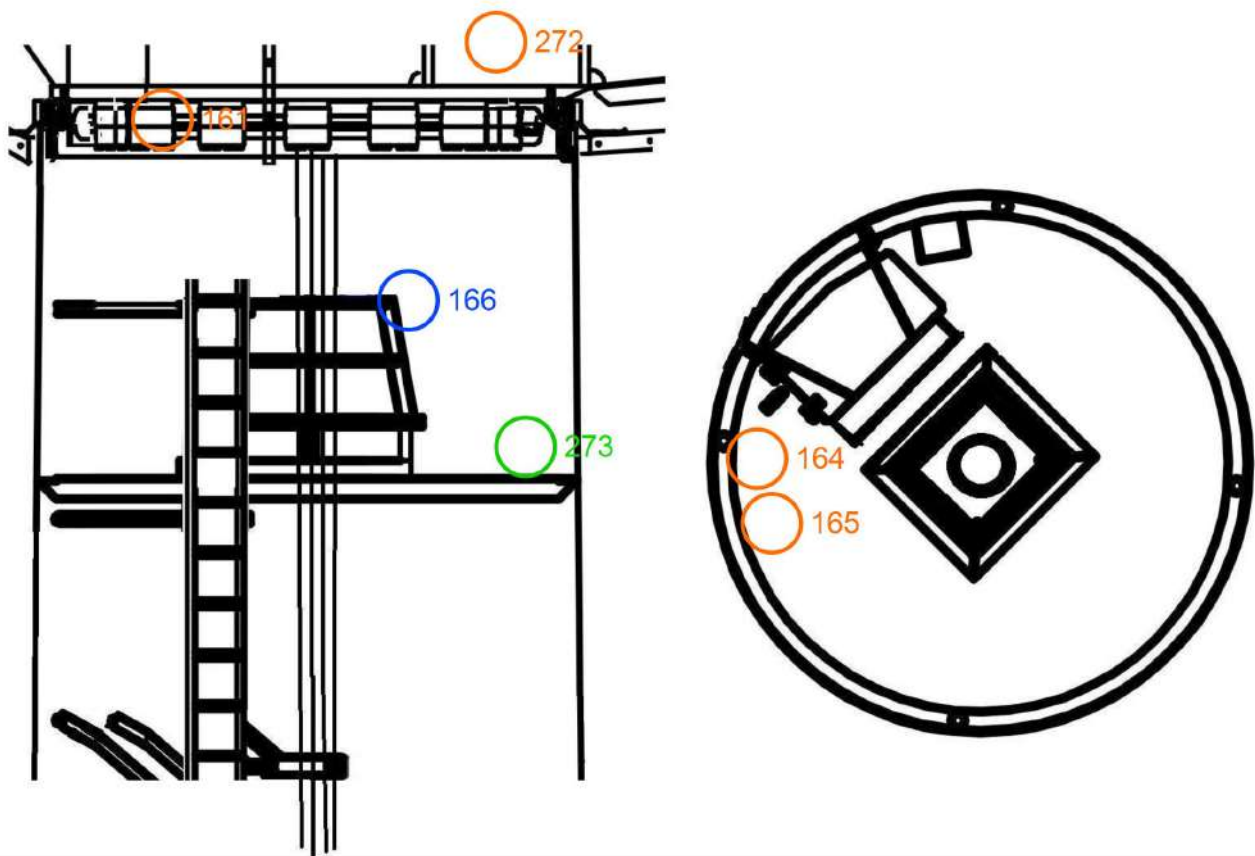
## D.9 Yaw platform

Nacelle, Yaw plate / Yaw system : Yaw brake disk. Grease contamination. The nacelle bearing sealing get tired. To exchange.
- 164 P Identification and labels : Safety stickers. Missing.
- 165 P Identification and labels : Max. load sticker. Missing.
- 166 E Foundations and tower, Platforms inside installation : Acces ladder. Should be equipped with anti slip pads.
- 272 P

Nacelle, Hydraulics : Hydraulic station. Corrosion at the accumulator.
- 273 V Foundations and tower, Platforms inside installation : Additional stool. Present.

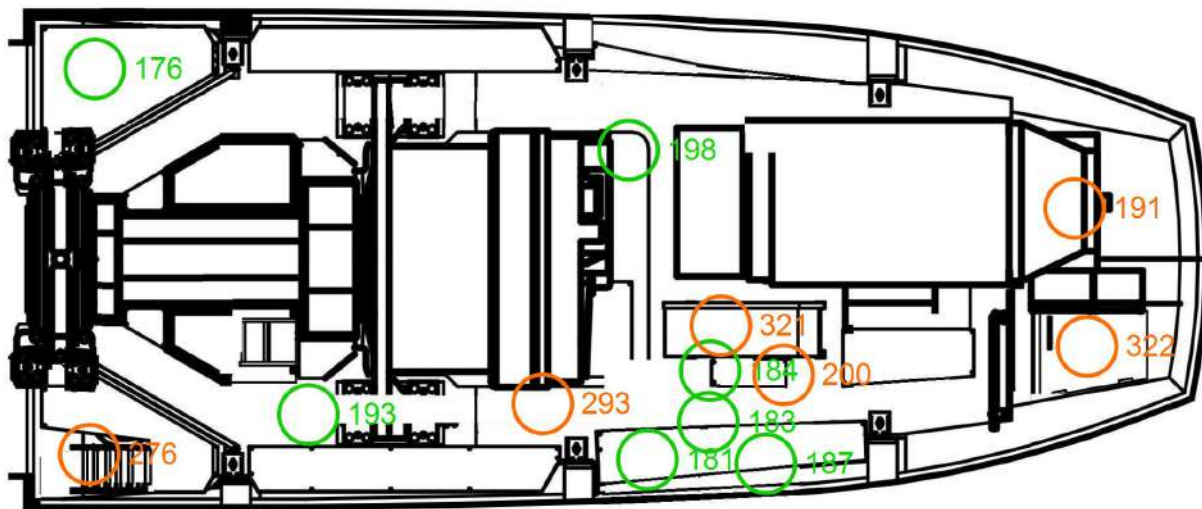
## D.10 Nacelle

- 187 V Health, safety and ascent systems : First aid kit. Present.
- 191 P Drivetrain, Generator : Generator slipring. Carbon Brushes. Irregular wear.
- 193 V Nacelle, Platforms inside installation : Cleanliness. Good condition.

- 293 P Drivetrain, Gearbox / lubricating system : Gear oil main block filter. Leakage. To eliminate.
- 321 P Nacelle, Electrical cabinets : Top controller cabinet. Important cracks at the rear cabinet's wall. Retrofit must be performed.

- 322 P Nacelle, Chassis / Structure : Service crane hatch. No information regarding the maximum load on the hatch.

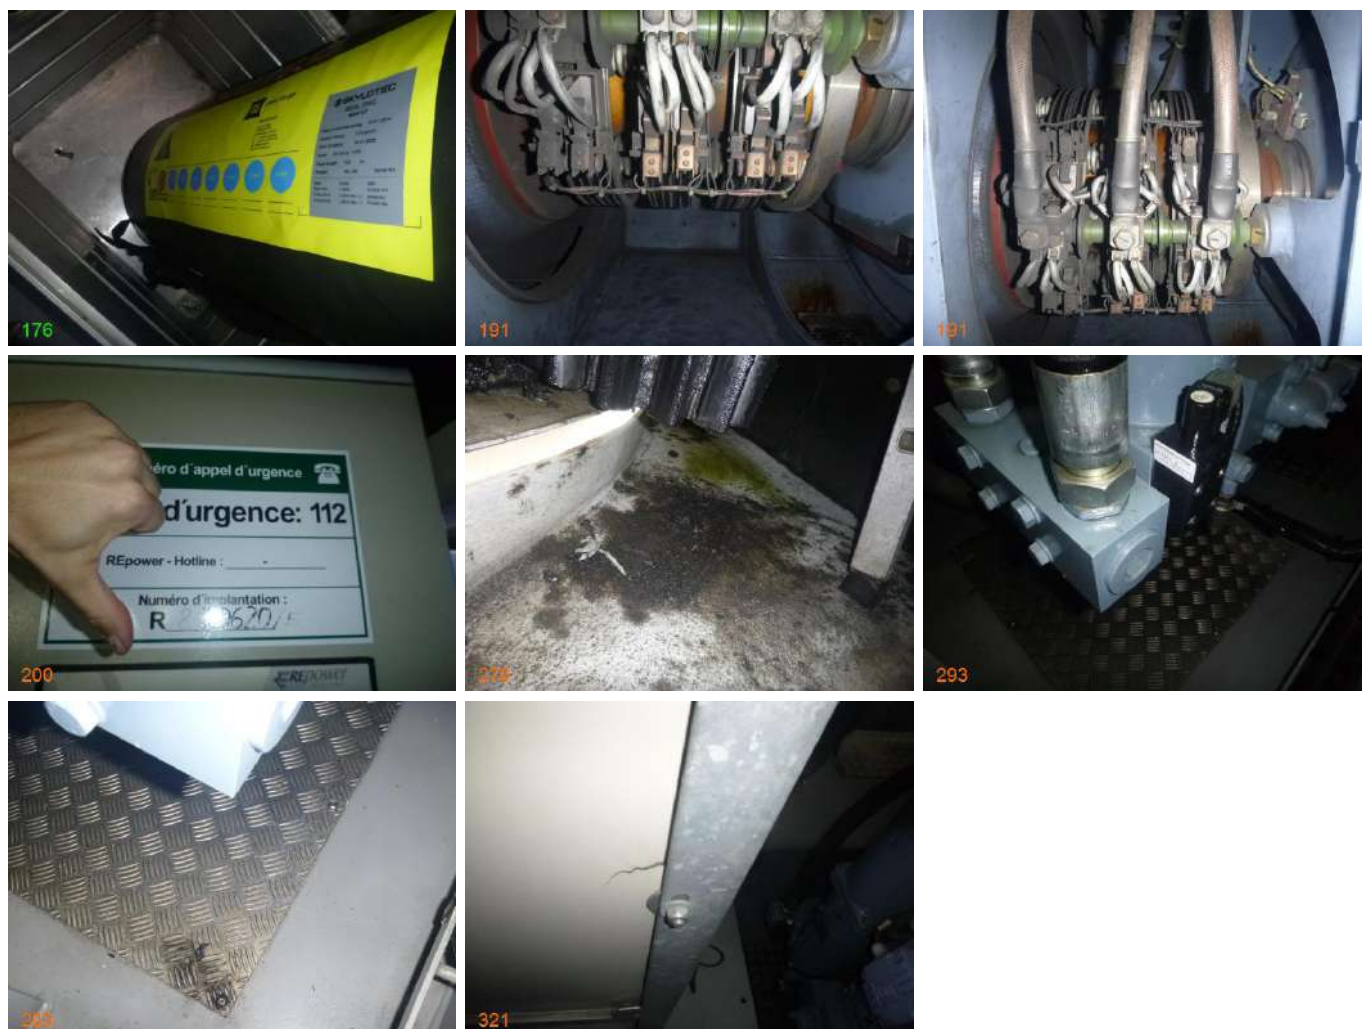
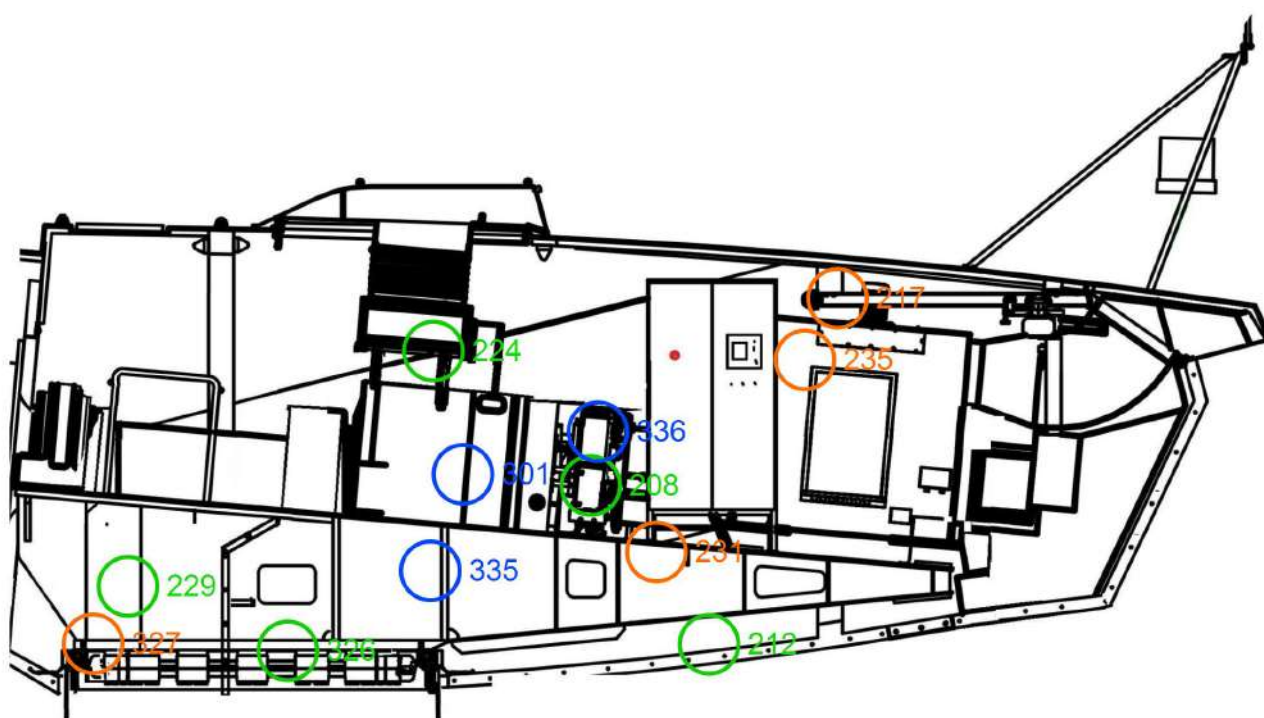
- 208 V Drivetrain, Gearbox : Oil level. Ok.
- 212 V <sup>Ⓜ</sup> Nacelle, Nacelle housing : Lower nacelle casing. Clean
- 217 P Health, safety and ascent systems : On board hoist. Rail. No restriction displayed for the use as an attachment point for the PPE against fall. Ask to REpower the proof that the rail can be used as an attachment point for the PPE against fall.

- 224 V Drivetrain, Gearbox / lubricating system : Cooler. Good conditions.
- 229 V Nacelle, Yaw plate / Yaw system : Yaw gear. Oil level. Ok.
- 231 P <sup>Ⓜ</sup> Nacelle, Chassis / Structure : Coating protection. Important paint flaking. To repair.

- 235 P <sup>Ⓜ</sup> Nacelle, Cables / Electrical installations : Nacelle hand lamp. Missing.
- 301 I Drivetrain, Gearbox : Vidéo endoscopy. See additionnal report. réf: Ménil la Horgne\_E5\_R70620\_VE report

- 326 V Nacelle, Yaw plate / Yaw system : Yaw gearing. Properly greased.
- 327 P <sup>Ⓜ</sup> Lightning protection equipment : Nacelle/tower continuity. The brushes are contaminated with excess of grease. The supports are contaminated with corrosion. To correct.

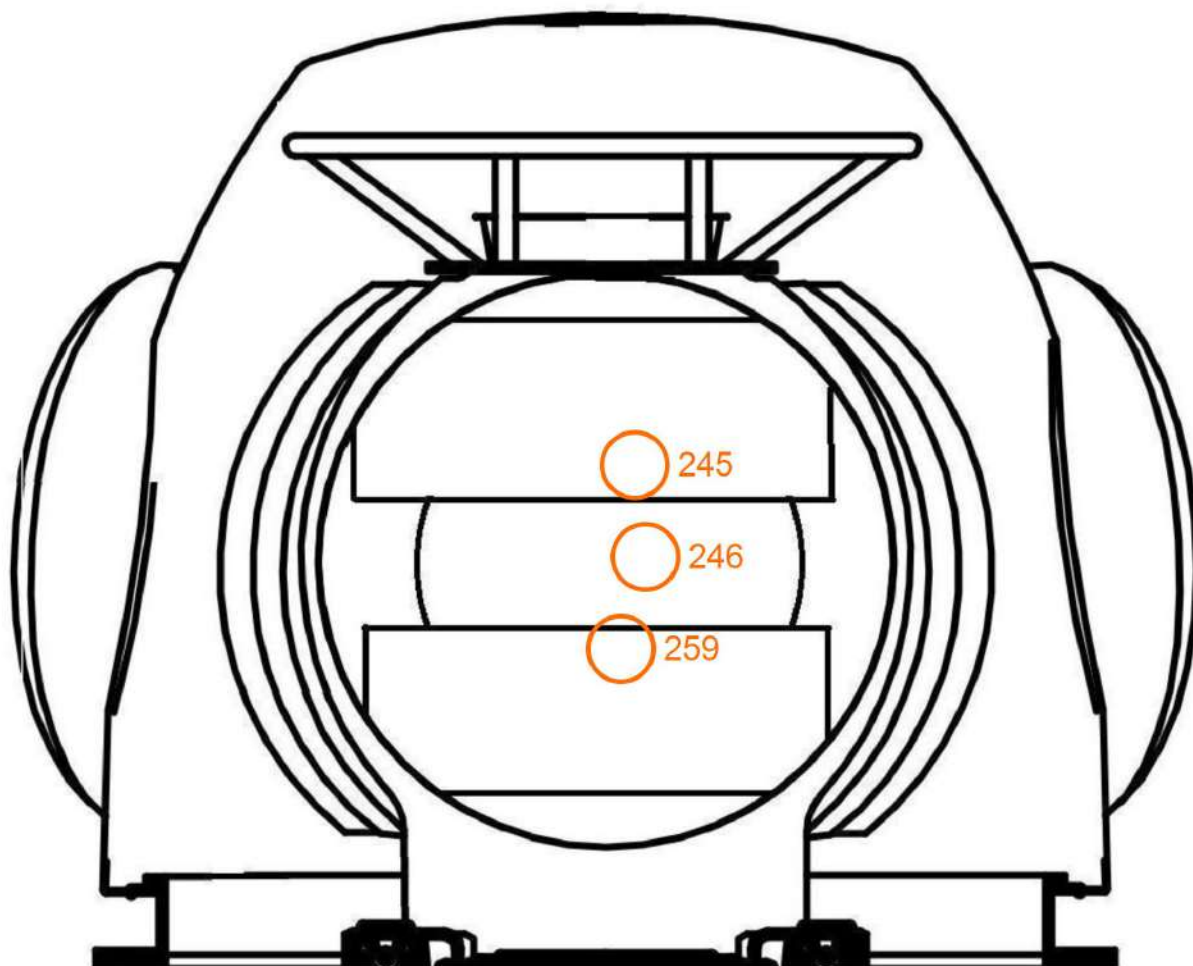
## D.11 Hub

Hub system : Hub enclosure. Contaminated with excess of grease. To clean.
- 246 P Identification and labels : Blade root platform. Maximum admissible load. Missing.
- 259 P Identification and labels : Warning and informations stickers. Must be translated in french.
